Proper Functioning Condition
And
Amendment 6 Assessments and Ratings
For
Monache Allotment
Summer 2010 and 2011

Prepared by: Lisa Sims, Inyo National Forest Aquatic Biologist

December 2011

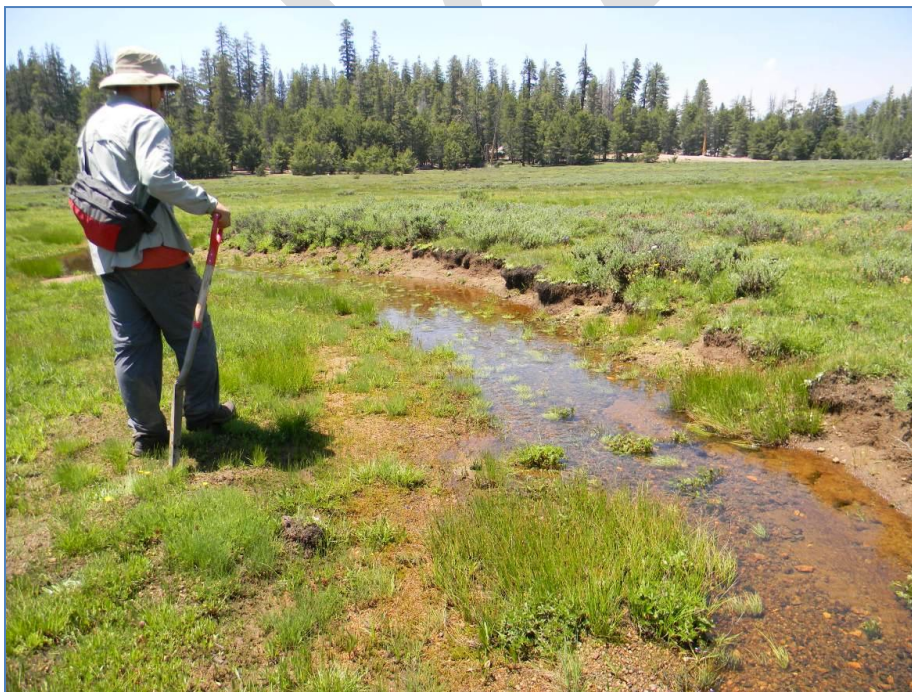
Watershed Rating: Big Dry Meadow was rated for watershed condition as At Risk. All factors rated as Level 4 except for Headcuts and Nickpoints, which rated as Level 2. It appeared that the channel was not functional because of numerous isolated pools within the channel, which put it in the Level 2 category. However, on a subsequent trip in September for utilization monitoring, it was obvious that the “stream” was a dry, ephemeral channel that was active only during high run-off. The ephemeral ponds were dry. This parameter may need re-assessment.

Photo above: The ephemeral channel within Big Dry Meadow, showing some of the degrading banks.

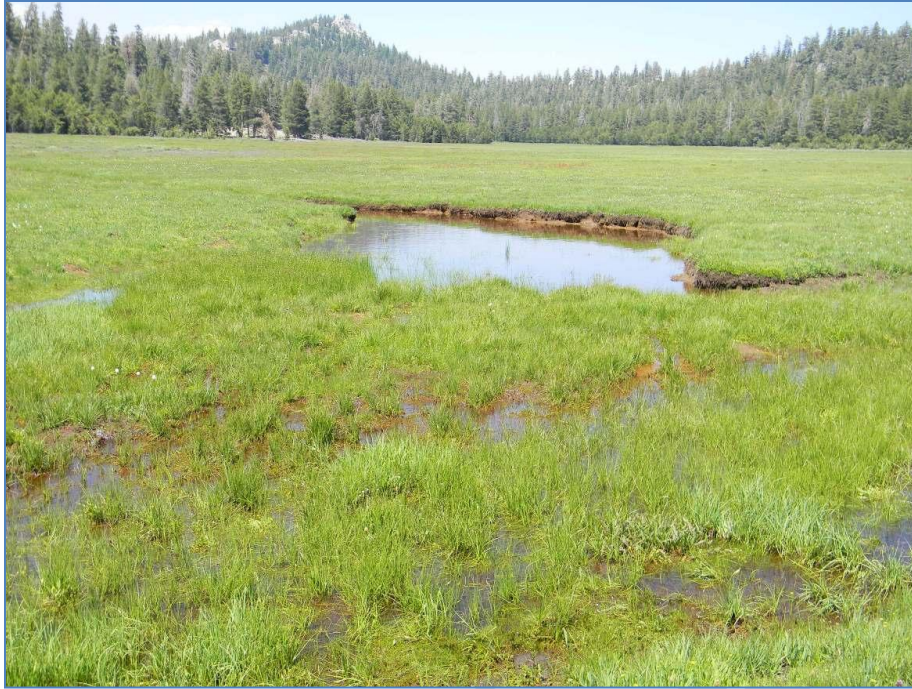
- **Headcuts:** Several were observed; some were enhanced by rodent activity. Large, crescent-shaped overland-flow type headcuts were present; however, they are more likely to be ephemeral ponds than headcuts, much like the ones observed in the meadow tributary to Death Canyon on the Templeton Allotment. Because there were no headcuts within perennial streams observed during a September 2011 field visit that threatened the meadow, this rating should be considered to be raised from the Degraded category initially recorded in the July 2011 assessment to At Risk or even Fully Functional.

Photo above: Illustrating the very wet conditions in mid-July of 2011 in Big Dry Meadow. In the center is an example of the ephemeral ponds within the meadow.

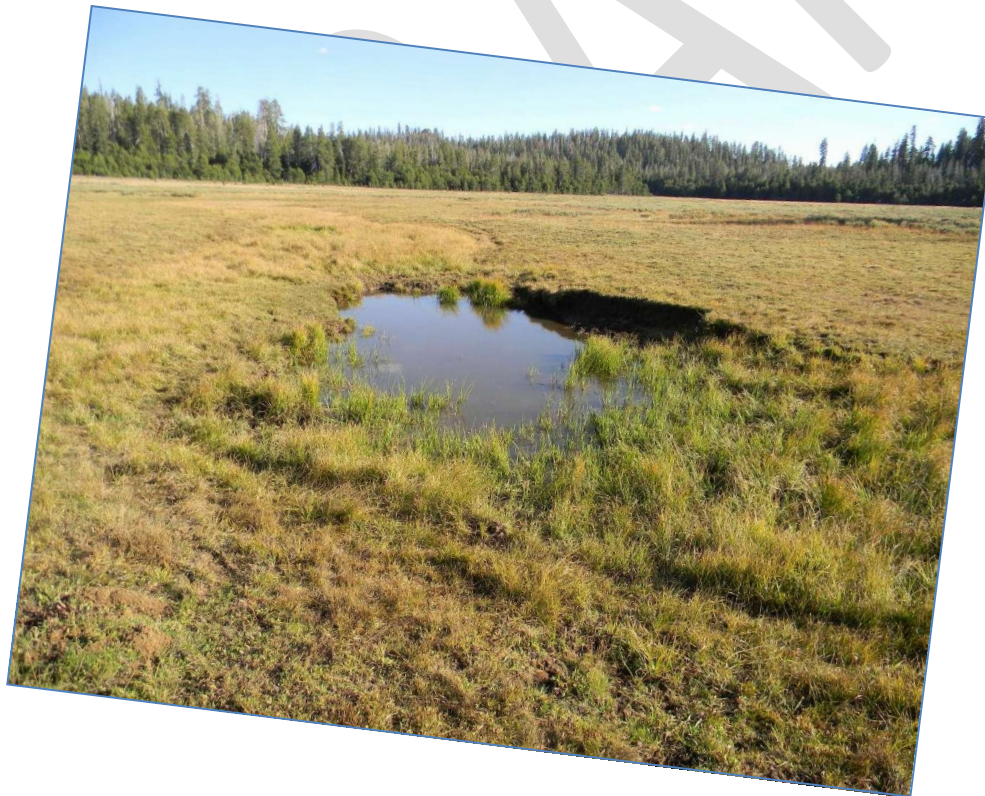
Photo above: A different ephemeral pond in Big Dry Meadow taken at the end of the summer season in September.

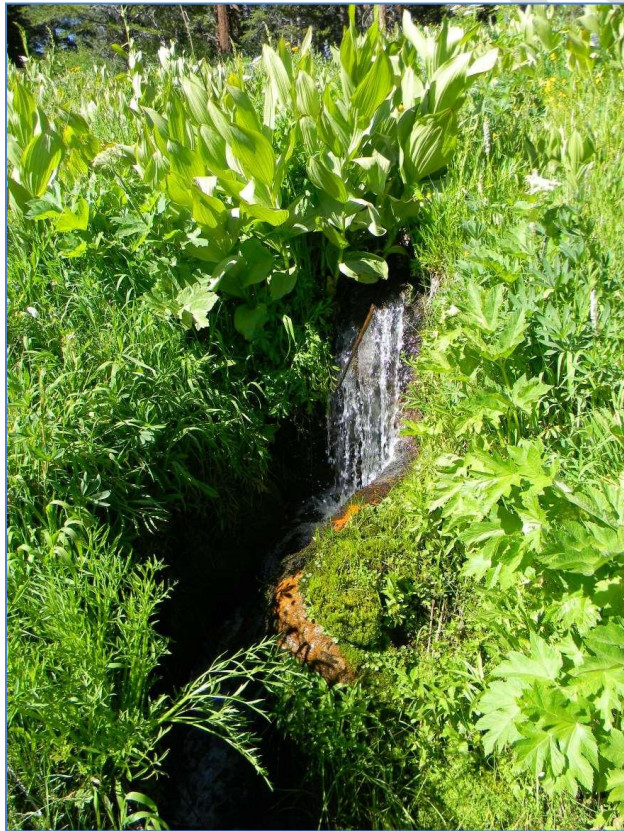
Photo above: One of the small waterfalls within the channel. This one was about 3 feet in height.

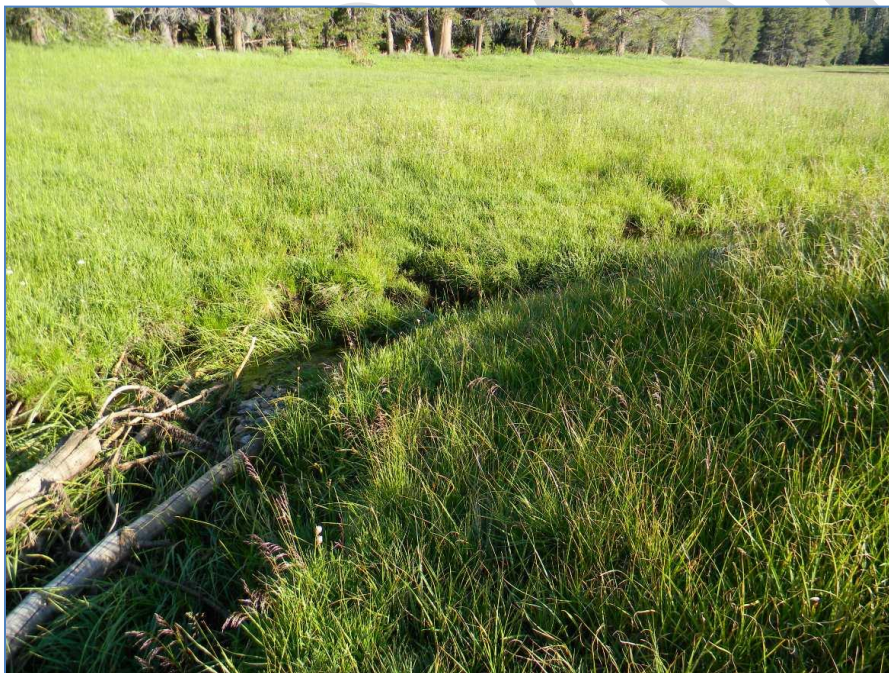
Photo above: Small stream channel through the lower end of Bull Meadow. Small trees were put in the channel to encourage sediment trapping, which appeared to slow down the headcut migration.

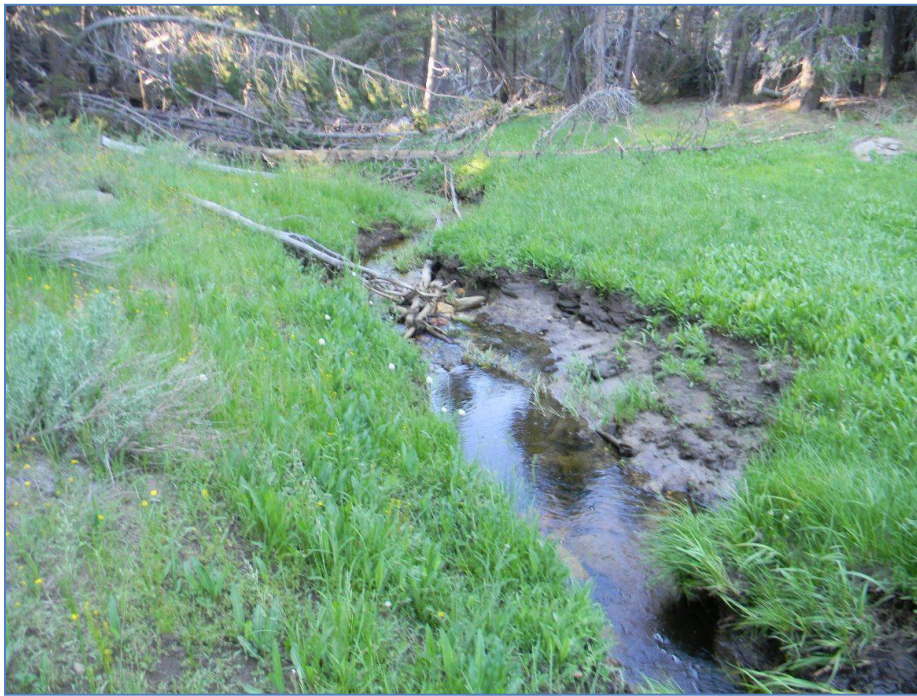
Photo above: Channel instability was observed in the stringer below the main body of Bull Meadow, but could threaten the stabilizing structures that are within the main meadow.

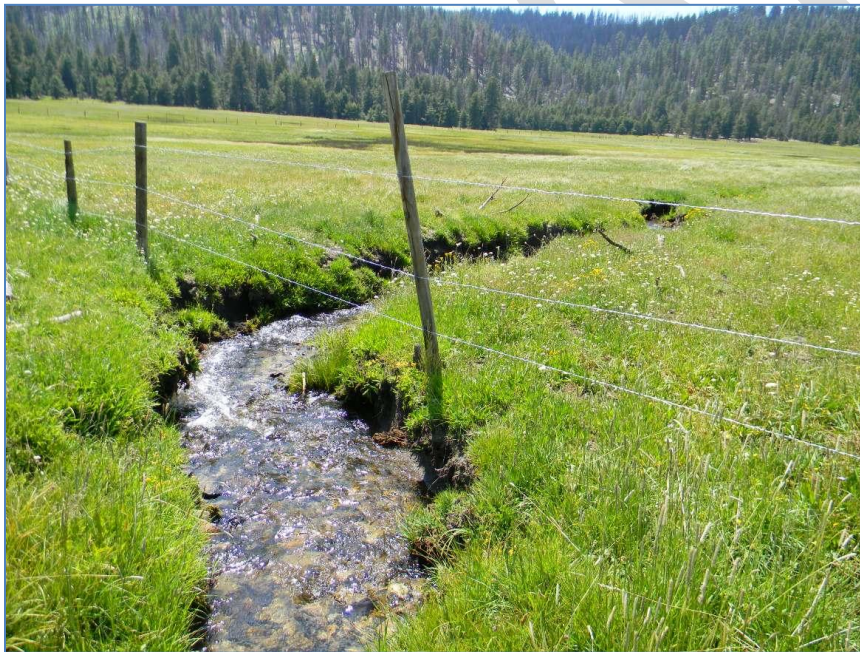
- **Headcuts:** The active headcuts located at the lower end of this meadow bring the meadow to its overall rating of At Risk. This headcut has been migrating from the inside the enclosure since about 2004, and has now migrated out of the enclosure. Headcut treatment is planned for 2012 to arrest the migration of this headcut.

PFC Rating: The presence of the headcut at the bottom of the meadow puts this entire riparian system at risk of losing meadow connectivity to the stream. As mentioned above, sinuosity is reduced within the channel, but this is more a function of the restoration process. The channel is perched up above the floodplain, putting it at risk of flowing out of the channel at high flow and finding the lower elevation. This would result in cutting through, or channelizing, the meadow.

Photo above: Incised channel as a result of the recent migration of the headcut from inside the enclosure (horse pasture) to the cattle use area in the eastern portion of Casa Vieja Meadow.

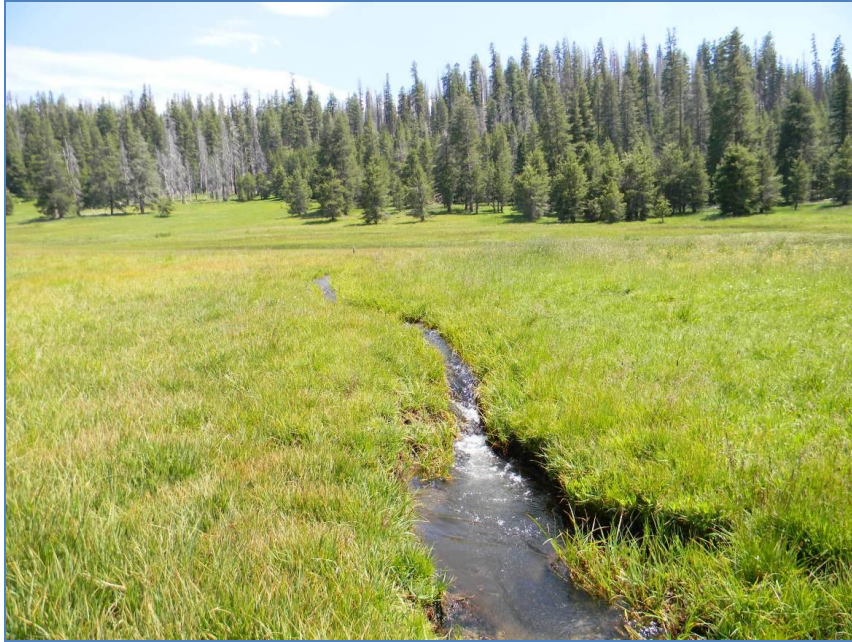
Photo above: The upper extent of the main headcut that is migrating through the cattle pasture in the eastern portion of Casa Vieja Meadow.

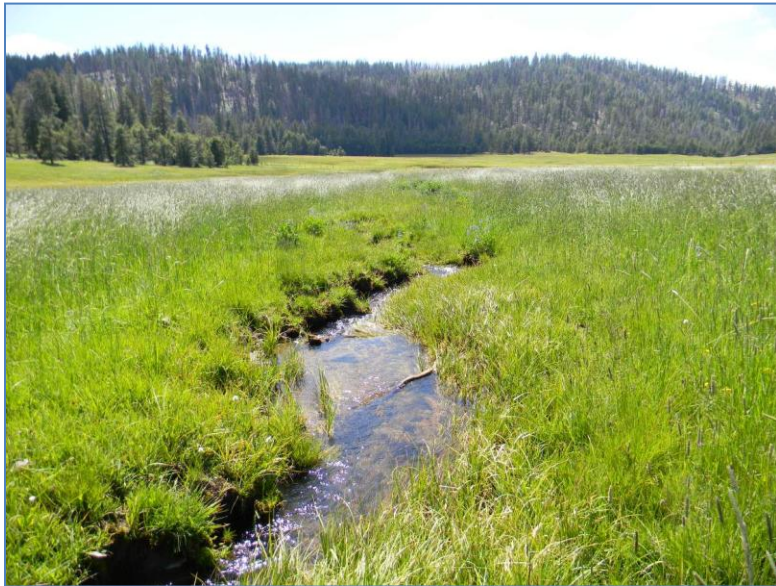
Photo above: Some instability within the channel was noted within Casa Vieja Meadow.

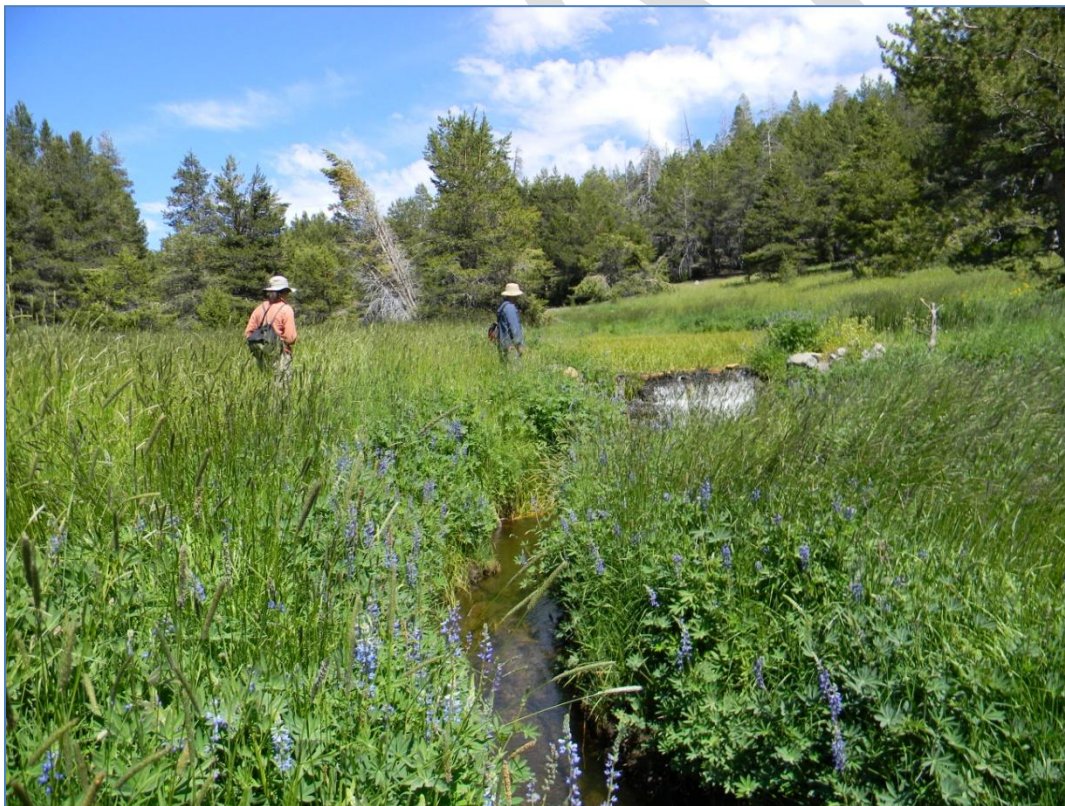
Photo above: One of the old headcut structures within Casa Vieja Meadow is visible in this photo. Note the wide, flat area above the structure that supports a robust *Carex* sp. community.

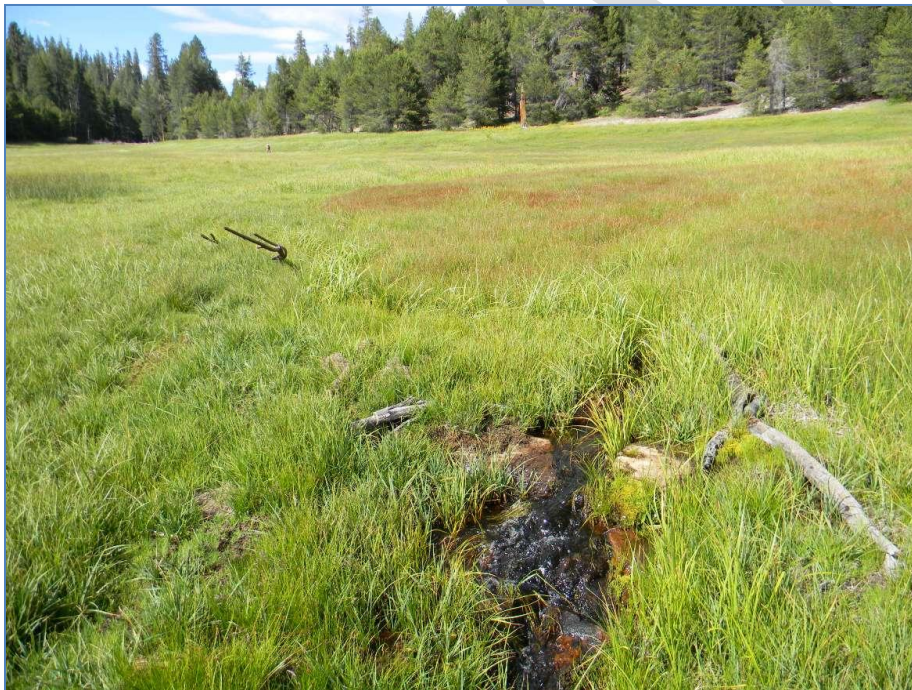
Photo above: Treated headcut within the north arm of Casa Vieja Meadow.

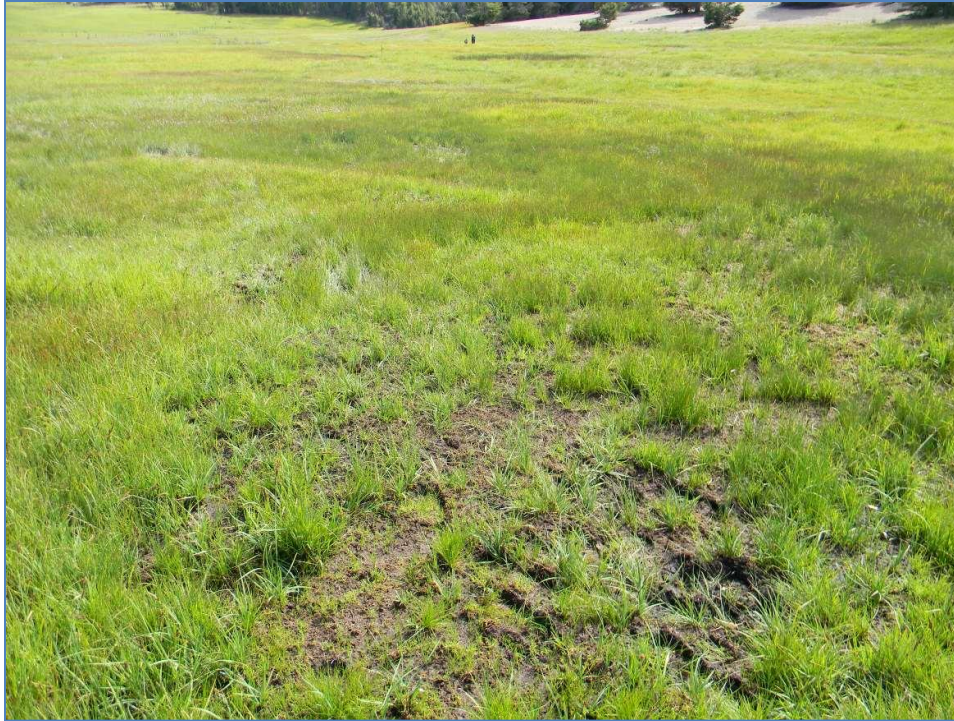
Photo above: In the foreground is bare ground that was observed in this section of Casa Vieja Meadow. It appears to be filling in with newly established *Carex* sp. vegetation.

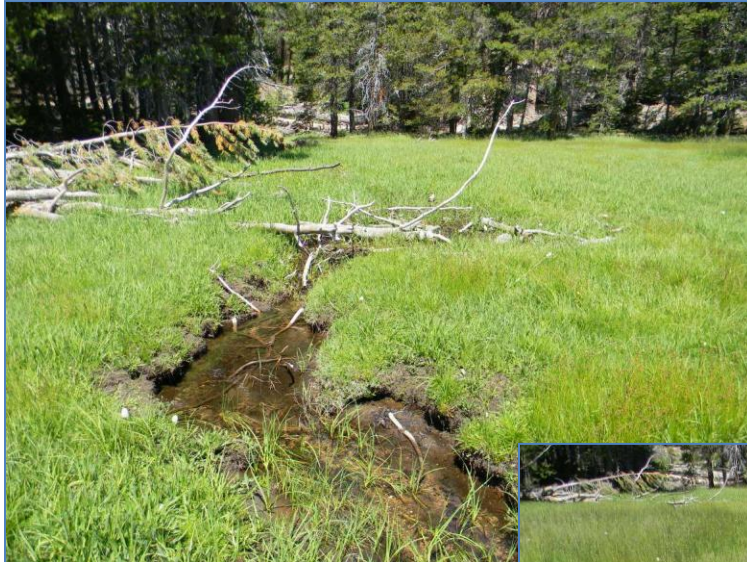
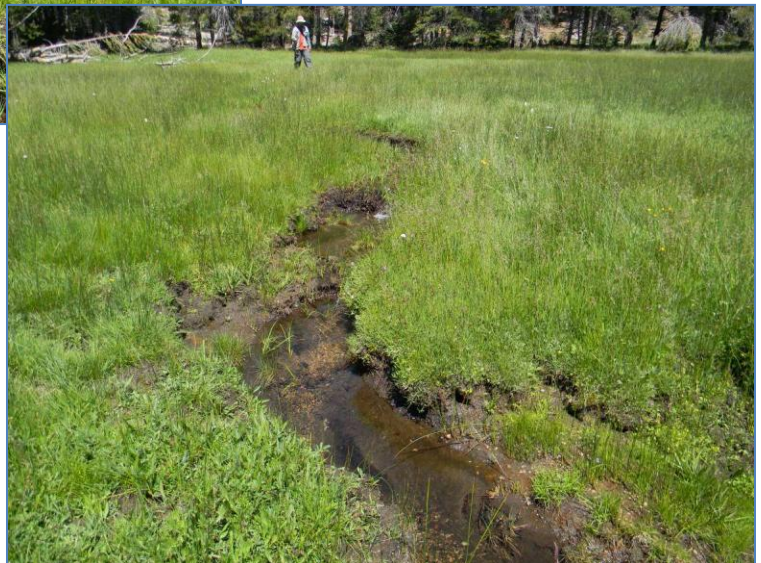
PFC Rating: This reach of the channel rated as Functional at Risk with an Upward trend. There were several small headcuts throughout the system that were active and still exhibited low-seral species along the banks. There were, however, several treated headcuts within the channel that were not actively migrating, were revegetating and appeared to be stabilizing, indicating an upward trend for this parameter.

Photos above and below: Two different headcuts which are migrating and unstable within Kingfisher Meadow.

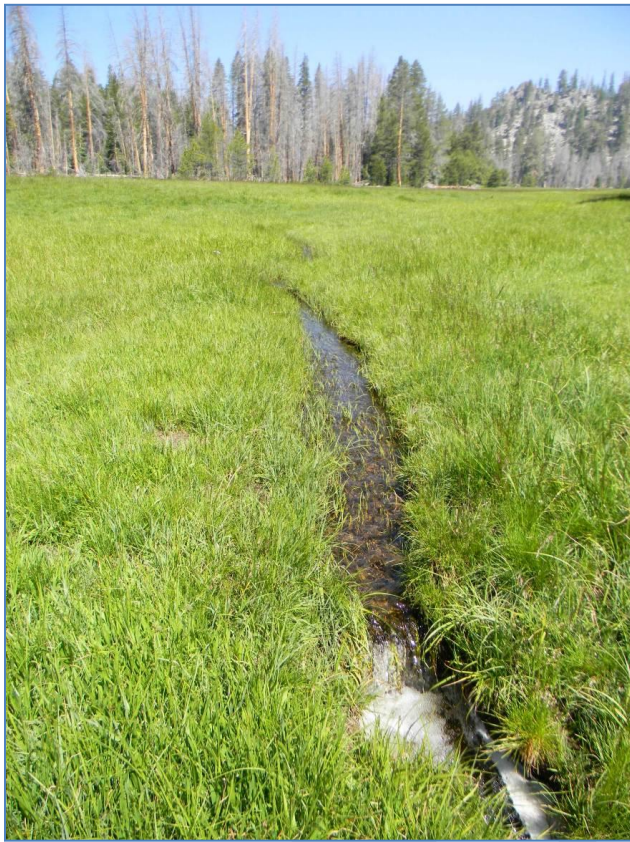
Photo above: A small headcut within the stream channel in Little Dry Meadow.

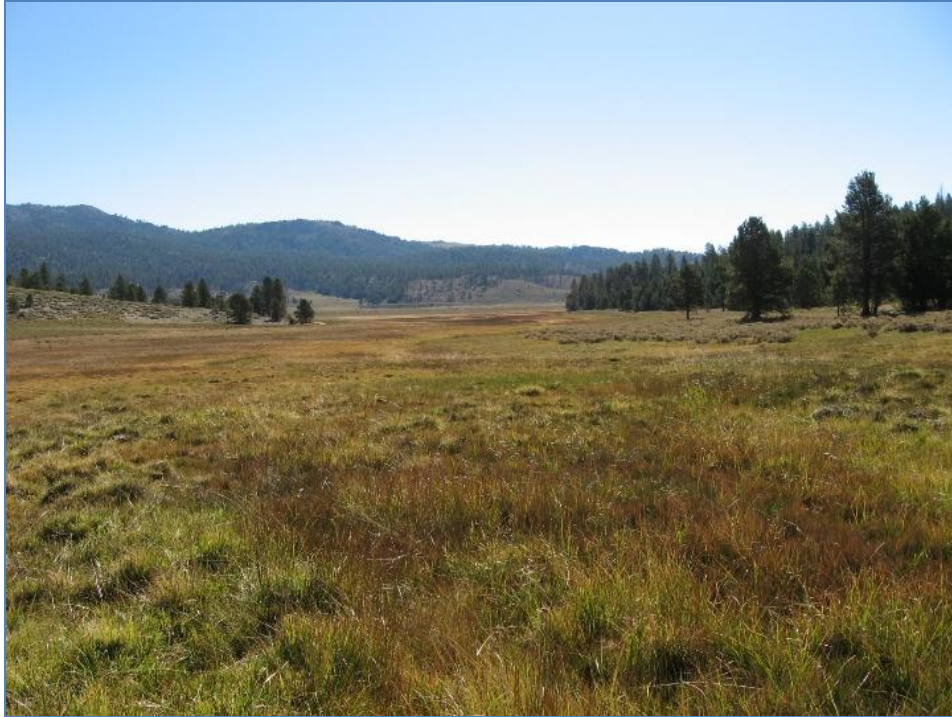
- **Hummocks:** Some hummocking was observed at the spring areas, with hummocks standing 8 inches tall at the maximum with no vegetation change noted on the tops.

Photo above: From the top of Bakeoven Meadow looking down towards the terminal basin. Hummocks within the spring area are obvious in the foreground.

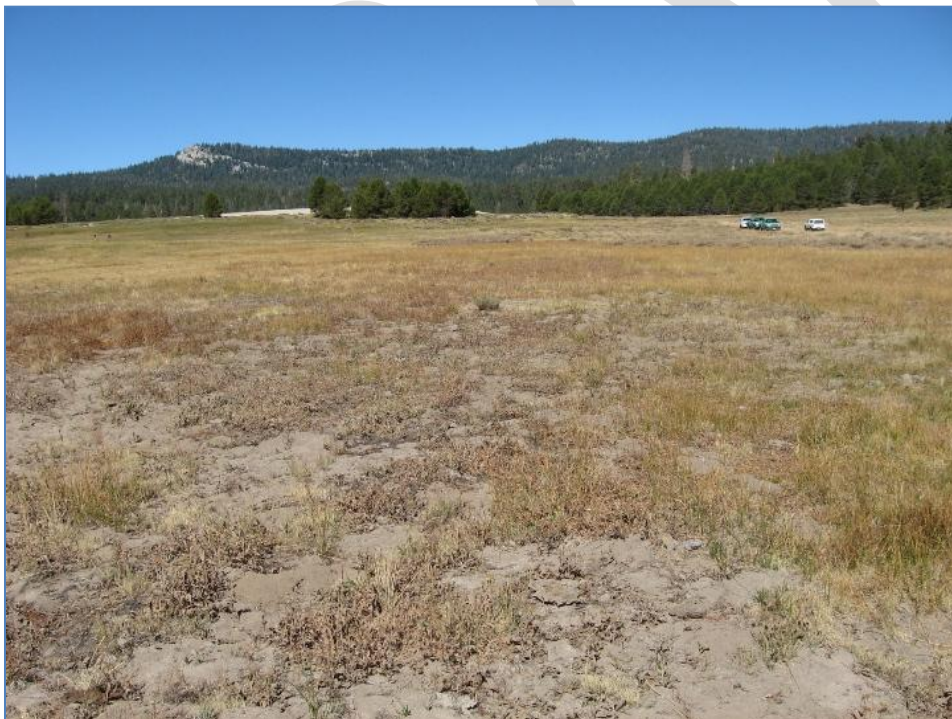
Photo above: Example of the alkali soil type with sparse vegetation within the Bakeoven Meadow area.

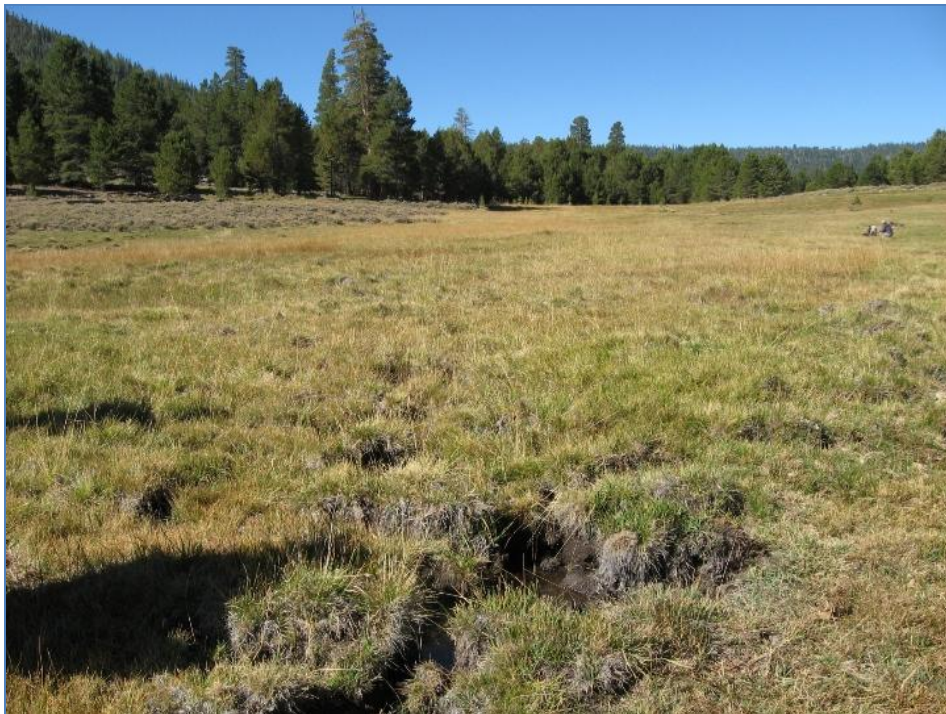
- **Rills/gullies and Bare Ground, Compaction:** No rills/gullies or compaction was observed, and bare ground was only noted in the alkali areas.
- **Headcuts:** Headcuts were rated as Level 3 from the small and unstable nick points and migrating headcuts that were noted at the upper end of the meadow within the spring mound. This would be an area that would be recommended for some type of restoration activity in order to halt the upward migration of the headcuts within the spring channel at the bottom of the spring mounds. The spring channel below the spring mounds was covered by a thick growth of vegetation with no nick points observed.

Photo above: Photo of small headcut moving up through the “spring mound” in Bakeoven Meadow.

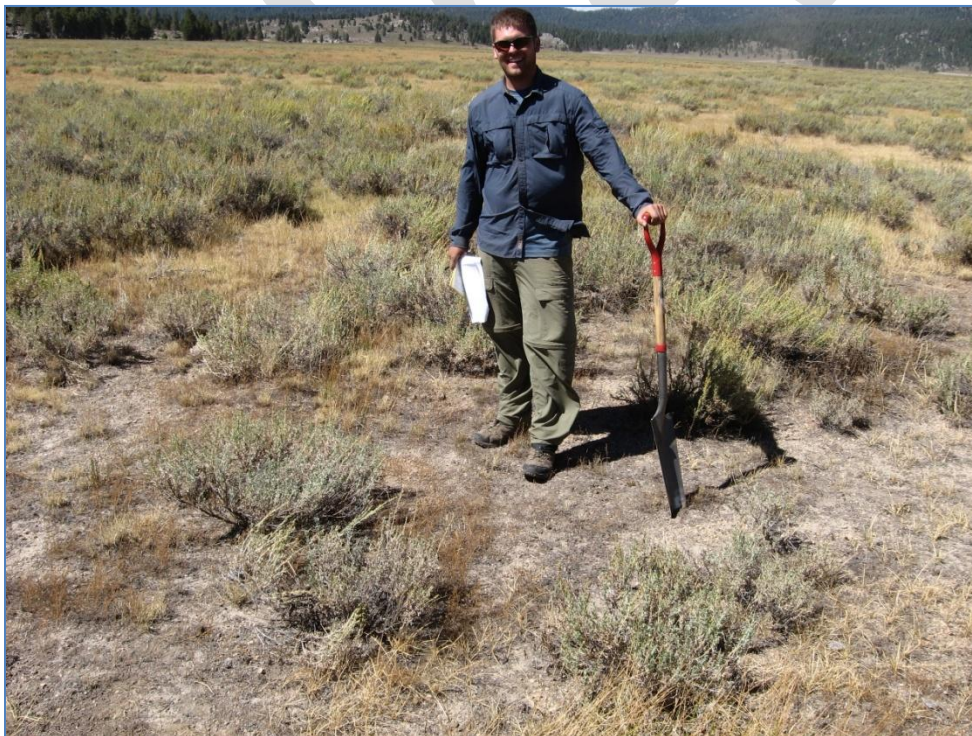
Photo above: Bare zones within the assessment area may be due to the dry year conditions in the area East of Crocker Field.

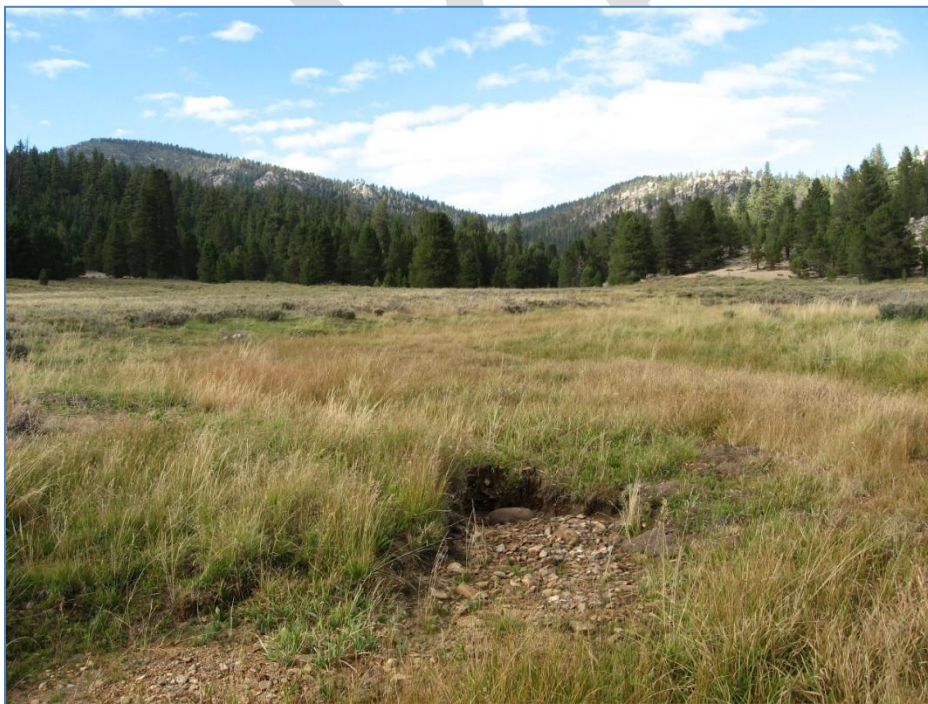
Photo above: One of the headcuts within the ephemeral channel, about 8 inches high, within Hessian Meadow.

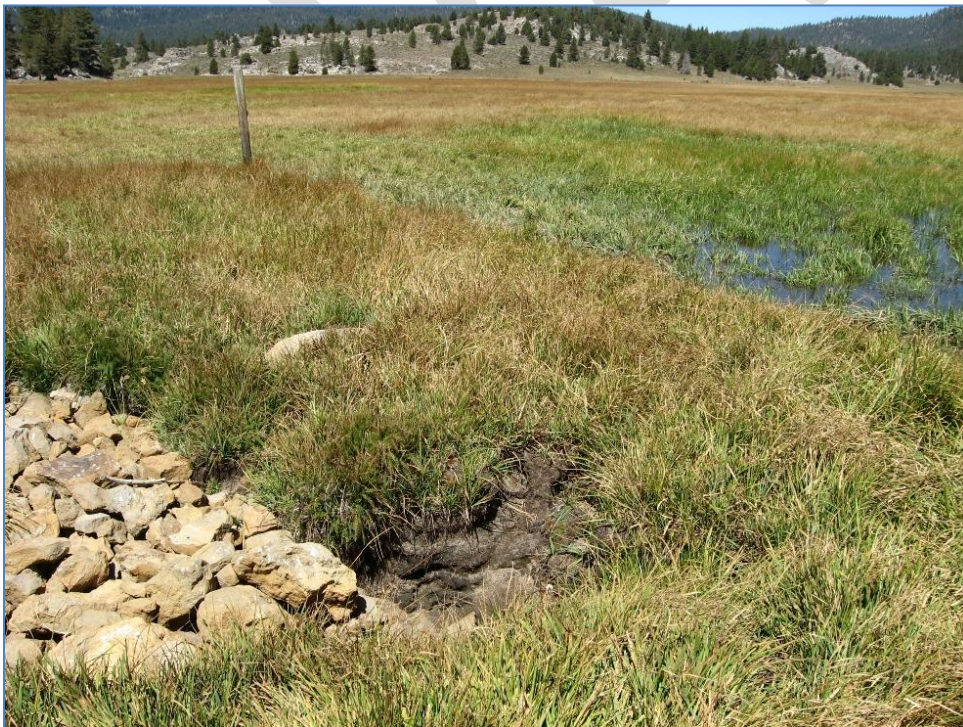
Photo above: This photo shows the headcut that has migrated past the treatment and is moving out of the fenced area in Lower Soda Meadow.

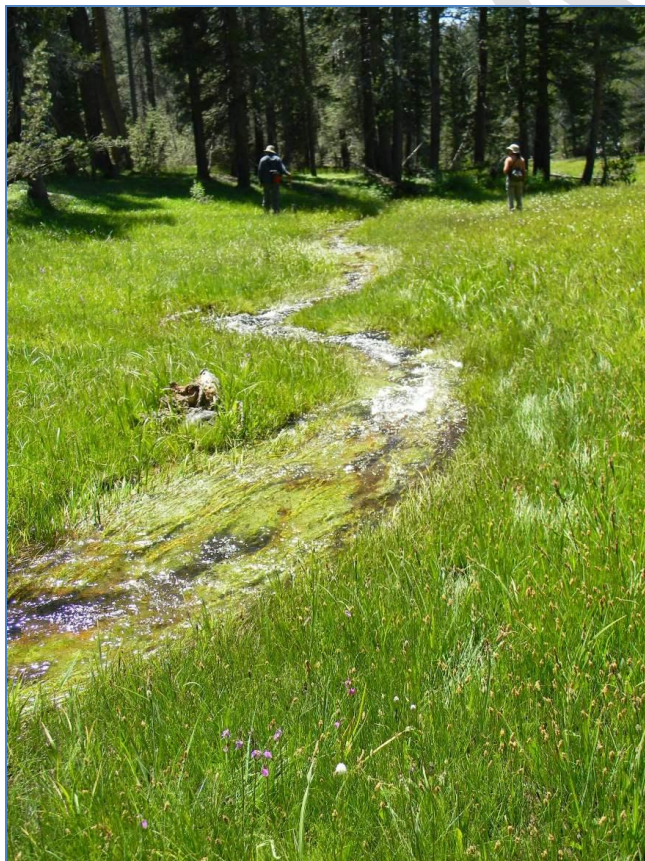
PFC Rating: The reach section below the Amendment-6 assessed meadow was rated at PFC, but did not include the section of channel where the treated headcut occurs. Banks were well-vegetated with a variety of species and age-classes, had relative features to dissipate energy and did not show any signs of bank collapse or channel migration during the 2011 run-off events.

Photo above: Adequate sinuosity and a variety of vigorous, high seral plant species and vertical stability puts this channel through Redrock Meadow at PFC.
